2. Title Evaluation of Cracking in the 241-AZ Tank Farm Ventilation Line	3. Number WHC-SD-WM-TI-478	4. Rev. No. 0
5. Key Words Stress Corrosion Cracking Hydrogen Embrittlement Residual Stress Cathodic Protection Austenitic Stainless Steel	6. Author R. P. Anantatmula / L. D. Blackburn Name (Type or Print) <i>R. P. Anantatmula</i> Signature Waste Management Technology/72500 Organization/Charge Code <u>WB4AB</u>

**EVALUATION OF CRACKING IN THE
241-AZ TANK FARM VENTILATION LINE**

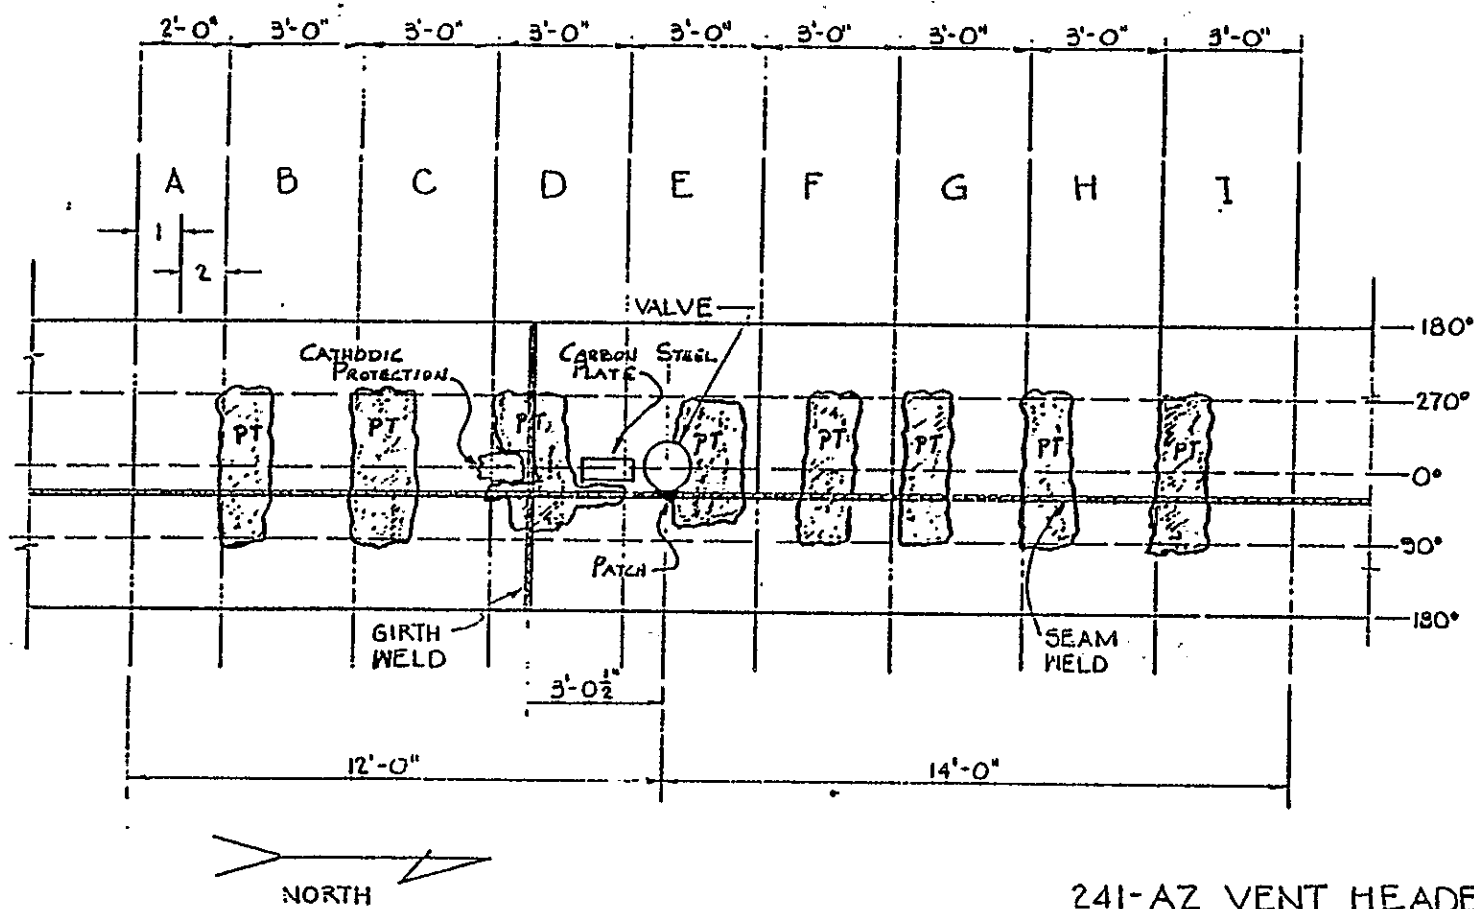
241-AZ VENT HEADER

Examination of the excavated ventilation line progressed in several stages. Figure 1 is a map showing all the areas examined by visual and liquid penetrant methods. In the eight areas examined (identified as Regions B through I, in Figure 1) only Regions D and E exhibited a consistent pattern of cracking. Figure 2 presents a schematic illustration of the observations in these two areas.

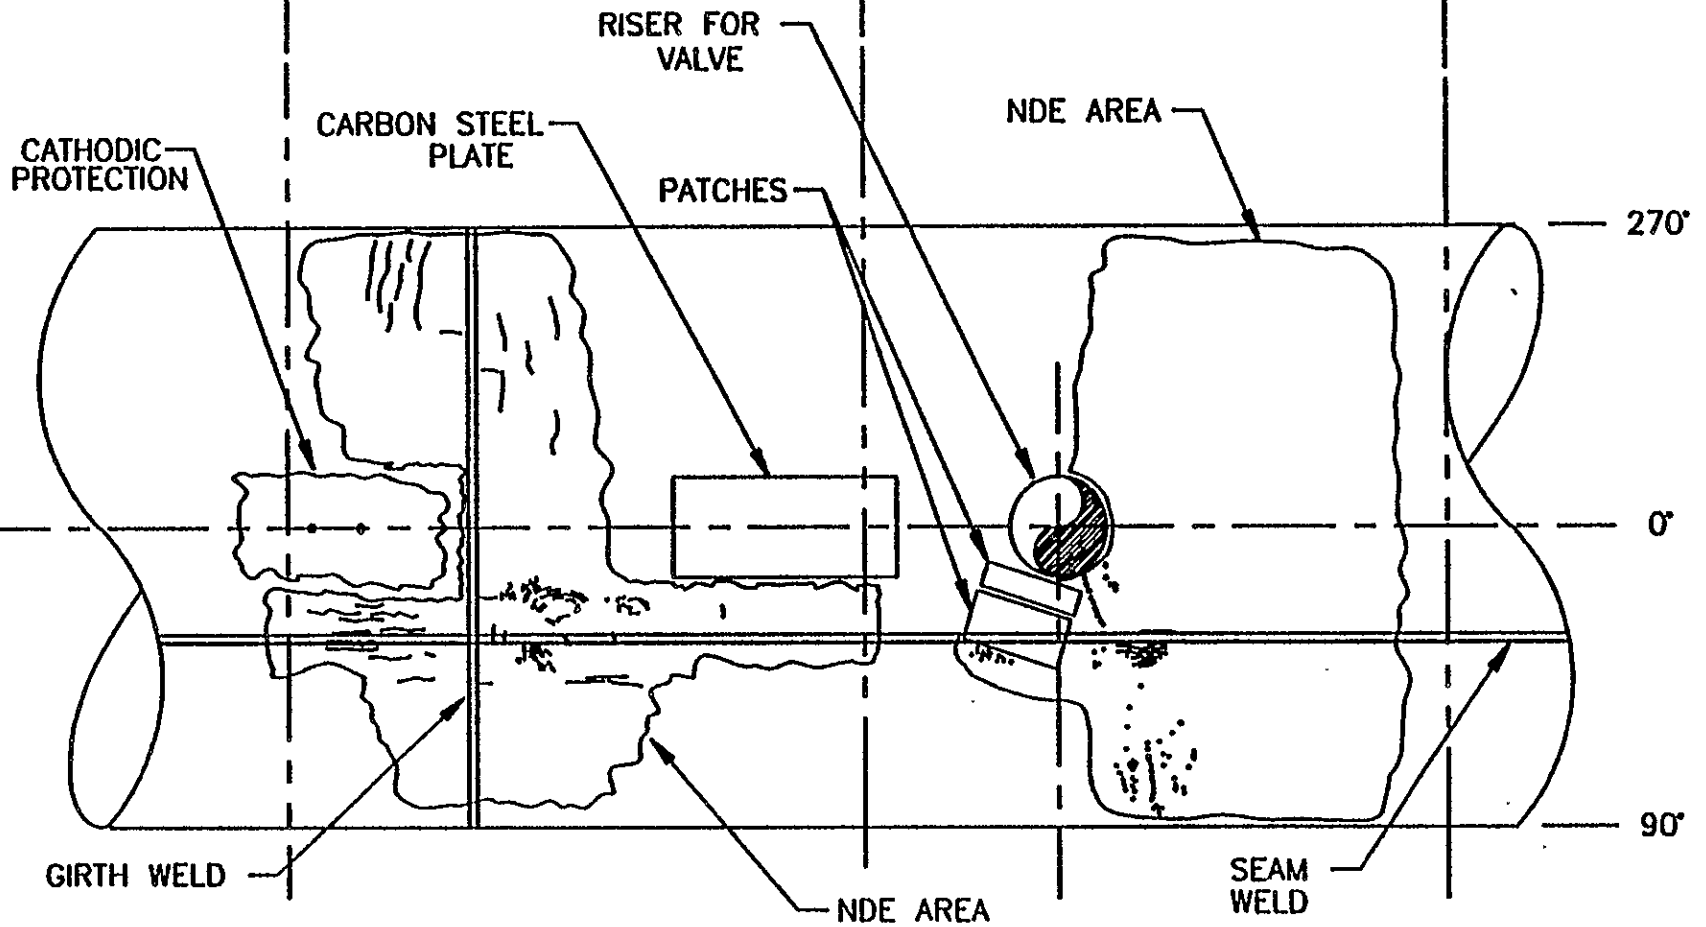
Figure 2: Schematic Illustration of Observations in Regions D and E.

Liquid penetrant examination around the fillet weld attaching the branch connection to the ventilation line revealed the first evidence of cracking. A single crack about 2-1/4 inches long appeared in the base metal about 1/2 inch away from the weld. Cracking caused by a very high temperature failure process should occur very close to the weld, where the temperatures are highest and thermally-induced plastic strains are greatest. The observed

A second crack about 1-1/4 inches long developed about 1/2 inch away from and parallel to a fillet weld made during installation of a rectangular patch to cover and seal the first crack. A qualitative model for the residual stress distribution around the fillet weld is that given by Masubuchi (1980, Page 193) for a restrained weld in a flat plate. That model suggests the stress transverse to the weld extends well into the base metal and could account for the orientation and location of the second crack.

Installation of another rectangular patch to cover and seal the second crack caused more cracks. Although residual stress around the fillet weld for the second patch should be similar to that for the first patch, the cracking response was markedly different. Cracks appeared in or near the pipe seam weld oriented transverse to the seam weld, rather than parallel to the patch fillet weld. Visual observations revealed two cracks located in the seam weld about 1/4 inch away from each corner of the patch prior to completing welding on the second patch. Although centered in the seam weld, these cracks extended into the base metal. These cracks were presumed to be through-wall cracks for the following reasons:

The final visual examination of Region E revealed a third crack across the seam weld about 2 inches from the north corner of the second patch. Liquid penetrant examination failed to detect this crack also, so it was classified as a through-wall crack.

A small area of intense cracking occurred in the base metal several inches north of the second patch just below the seam weld. The crack orientation was generally axial, but with some circumferential character evident.

The circumferential girth weld is a convenient location to start the cracking in Region D of the ventilation line. Four axial (i.e., transverse to weld direction) cracks occurred in base metal adjacent to the weld; no other cracking occurred within about one inch on either side of this weld. Residual stresses surely exist in and around this field weld, since post-weld heat treatment would not have been applied. The residual stress distribution given by Masubuchi (1980, Page 207) should represent the qualitative features of the girth weld stresses. Transverse cracks near the weld are consistent with tensile circumferential stresses at that location. Compressive axial stress on the outside surface is consistent with an absence of circumferential cracks. Liquid penetrant examination conducted after completing the girth weld should have revealed base metal cracking associated with pipe installation, so transverse cracks near the girth weld must have formed during service. This finding suggests that the other cracking in this region also developed during ventilation line service.

In the pipe north of the girth weld, eight transverse cracks occur in the seam weld at distances of 1-8 inches from the girth weld, but no seam weld cracks occur at distances of 8-24 inches from the girth weld. One small area of intense cracking occurs in the base metal just below the seam weld about 5 inches from the girth weld; the orientation of this cracking is basically circumferential (i.e., the same as transverse cracks in seam weld), but some small axial cracks also seem to be present. About 2-3 inches above the seam weld, there is a base metal cracking pattern which extends from 2-12 inches north of the girth weld. Near the girth weld, the cracks are oriented circumferentially, but they gradually change toward an axial orientation farther from the girth weld. A similar, but less well-developed, type of cracking is observed several inches below the seam weld. On the west side of this pipe a number of faint, isolated cracks with circumferential orientation are evident.

In principle, limited surface cracking on the pipe could be accepted. Structural integrity of pipe with existing flaws can be demonstrated by methods of fracture mechanics. In addition, calculations should show that future slow growth would be acceptable. However, at the present time, knowledge of the cracking process is insufficient to conduct such evaluations. Even if the mechanism were known, information on fracture toughness values and kinetics of crack growth needed for a quantitative assessment is not available.

Although the vent line is under a slight negative pressure relative to the outside environment, a preliminary safety evaluation has been completed (Fein, 1991) to determine the acceptability of the through-wall cracks, as they represent a path for release of radioactive contamination. The safety evaluation results indicate that, under normal operating conditions, leakage of vent gases via the three through-wall cracks would not result in a significant increase in the existing hazard to the environment. In spite of this assessment, options for repair of the cracked section should be pursued to assure complete containment of any leakage of the vent gases through the through-wall cracks. Such repair of the cracked section is recommended to assure compliance of the ventline with current regulations until a totally new ventline system is installed under project W-202 in 1997.

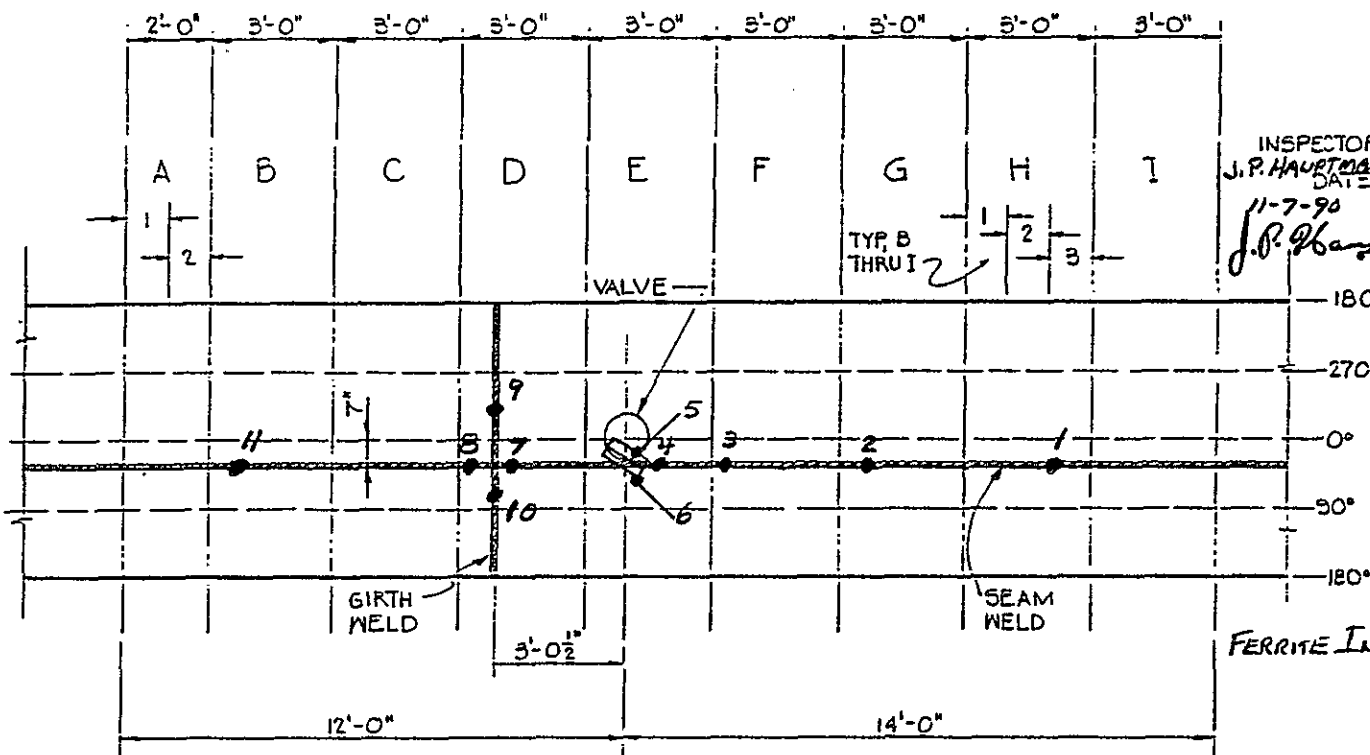
FERRITE CONTENT
241-AZ VENT HEADER
INSPECTION RECORD

- NOTE: 1) 10' NORTH OF VALVE : < 2.5
 2) 6' NORTH OF VALVE : < 2.5
 3) 3' NORTH OF VALVE : < 2.5
 4) SEAM WELD AT PATCH : < 2.5
 5) UPPER PATCH WELD : $> 5.0, < 7.5$
 6) LOWER PATCH WELD : $> 7.5, < 10.0$
 7) NORTH SEAM AT GIRTH WELD : < 2.5
 8) SOUTH SEAM AT GIRTH WELD : < 2.5
 9) GIRTH WELD AT 315° : $> 7.5, < 10.0$
 10) GIRTH WELD AT 45° : $> 7.5, < 10.5$
 11) 8' SOUTH OF VALVE : < 2.5
 12) RANDOM BASE METAL : < 2.5
